Manhole Inspection Summary

Manhole # S07UU1006MH

Insp Date: **9/27/06 12:15 PM**

Location Address: **3000 W ROGERS AVE**

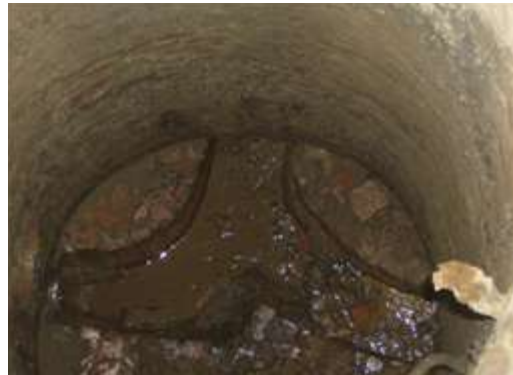
Top View

Condition: ☐ Sound ☐ Cracked ☐ Root Intrusion ☐ Deteriorated ☐ Leaks ☒ **Debris**

Count: **4** Missing: **1** ☒ **Corroded**

☒ **Evidence Of Surcharge** Depth: **1.5** (ft.) ☐ Active Surcharge Present

Corroded and missing steps. Evidence of surcharge - Bench debris. Channel debris.

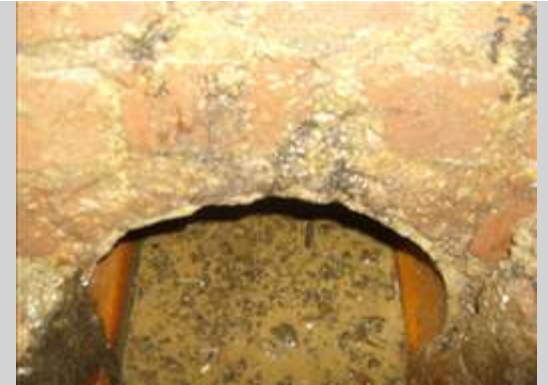
8 in. Circular Gravity Sewer Pipe Out @ 12 O'Clock

Deposits: ☐ None ☒ **Mud** ☐ Sludge ☒ **Debris** ☐ Grease

Silt Depth: **1** (in.) Deposits Extent: **Light**

Infiltration: **Evidence** Pipe Seal Cond: **Unknown**

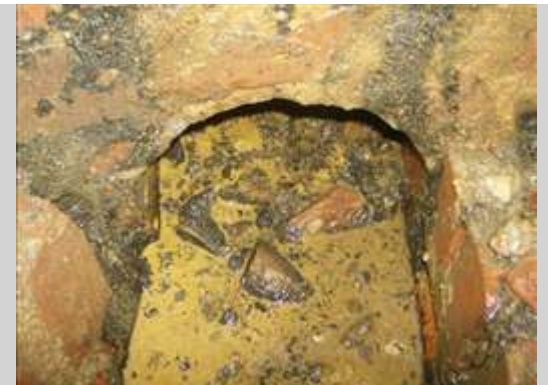
8 in. Circular Gravity Sewer Pipe In @ 3 O'Clock

Deposits: ☐ None ☒ **Mud** ☐ Sludge ☒ **Debris** ☐ Grease

Silt Depth: **2** (in.) Deposits Extent: **Medium**

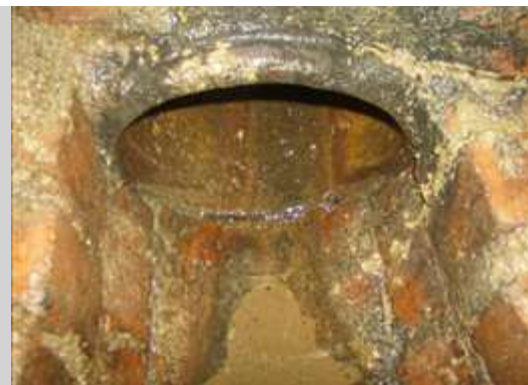
Drop In @ 9 O'Clock

Drop: **Outside** Rod and Bar

Drop Condition: **Open**
